Application Note AN # 77

Contactless analysis of mural paintings with a new portable FT-IR analyzer

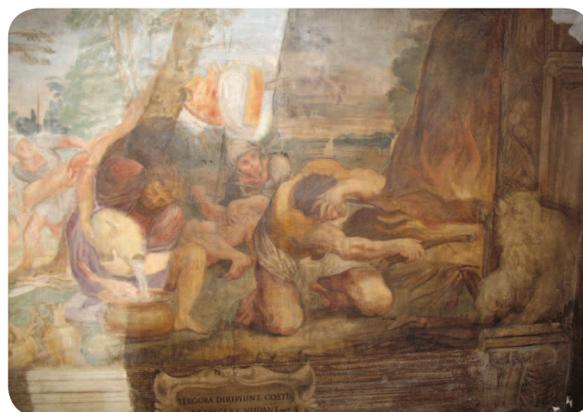
Figure 1: Mural painting by Francesco Albani in Bologna, Italy, during restoration process ^[1].

The ALPHA FT-IR spectrometer proved its high potential during the restoration of mural paintings by Francesco Albani in Bologna, Italy (Figure 1 and 3). Selected areas of the mural paintings were analyzed before and after cleaning in order to decide on the best cleaning method and solvent or if the treatment is really effective. The spectra collected directly on the surface of the mural painting were compared to reference spectra from the library.

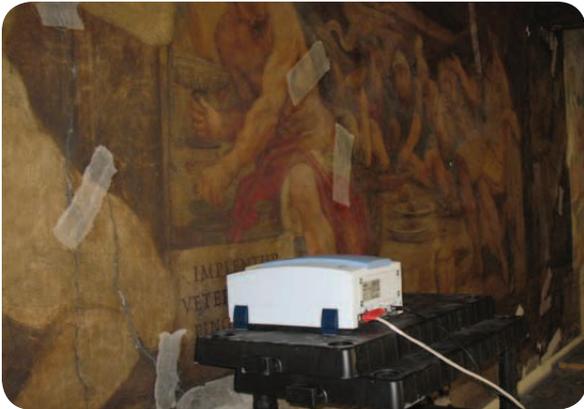
Figure 2: The ALPHA, equipped with a dedicated reflection module, is placed in front of the mural painting to perform the FT-IR measurements.

The ALPHA only takes up a 22cm by 30cm space, weighs about 7kg and can therefore easily be carried in a backpack.

As the ALPHA is insensitive to vibration, it can be placed almost anywhere, can be moved, and is immediately operational without any need for alignment. Equipped with a front-reflection module, which is designed for contactless and non-destructive FT-IR measurements, the portable ALPHA was placed in front of the mural painting (Figure 2). The ALPHA can also be placed on a tripod, the measurement position can be adjusted accordingly (Figure 8). In addition, the ALPHA's battery and wireless options enable extra portability features.

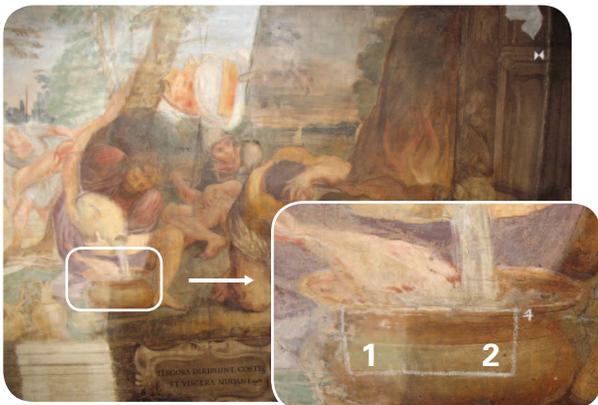
Figure 3: Detail of the mural painting during restoration process. Area 1: after cleaning; area 2: before cleaning.

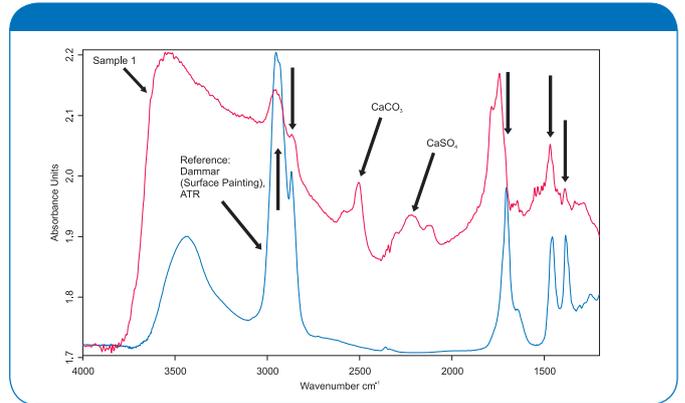
Figure 4: Spectrum of an area of the mural painting before cleaning showing typical absorbance of a terpenic varnish, calcium carbonate CaCO_3 and calcium sulfate CaSO_4 .

First, a spectrum of the mural painting before restoration was taken (Figure 4) and compared with a reference spectrum of a terpenic varnish (for example, dammar). Typical absorbance bands for terpenic varnish, calcium carbonate and calcium sulfate were identified. Subsequently, the same area of mural painting was treated with acetone and a new spectrum after treatment was taken to control the cleaning effectiveness. As seen on Figure 5, the terpenic varnish has been completely removed by the acetone treatment; the typical bands of varnish are missing in the spectra.

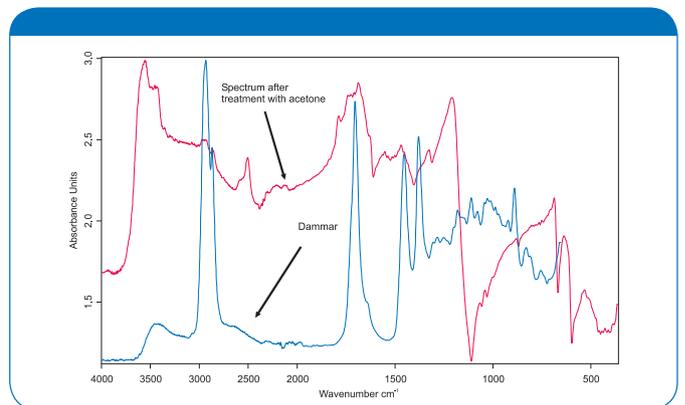
Figure 5: Spectrum (red) of the mural painting after treatment with acetone. The typical absorption bands of terpenic varnish (blue) are missing showing a successful treatment of the mural painting.

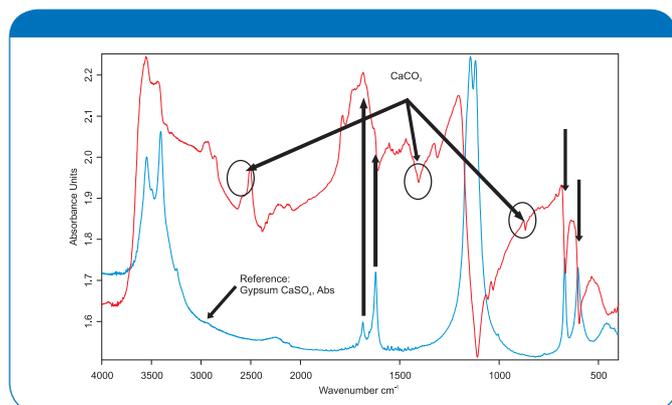
Figure 6: Spectrum (red) of the mural painting after treatment with acetone and comparison with a calcium sulfate reference (blue). Calcium sulfate and calcium carbonate are identified.

In addition, comparing the spectra of the treated mural painting with a spectrum reference for calcium sulfate (gypsum) from the library identifies the calcium sulfate and calcium carbonate (Figure 6).

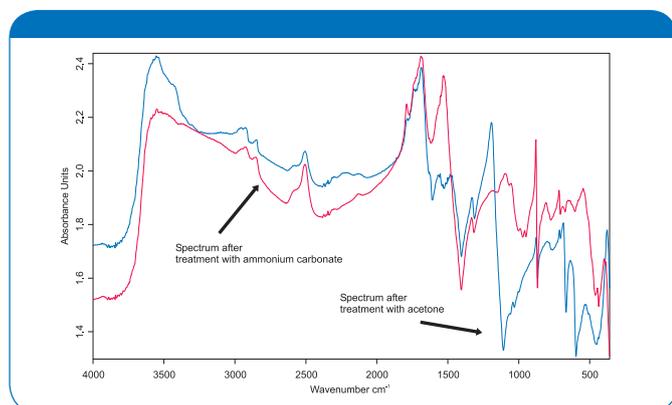
Figure 7: Spectrum of the mural painting after treatment with ammonium carbonate (red). Calcium sulfate was removed successfully. For comparison, the spectrum after treatment with acetone is displayed (blue).

Subsequently, one part of the mural painting was treated with ammonium carbonate to remove the calcium sulfate. Figure 7 shows the successful treatment on the mural painting surface by the ammonium carbonate treatment; no absorbance peaks of calcium sulfate can be identified after this treatment step.

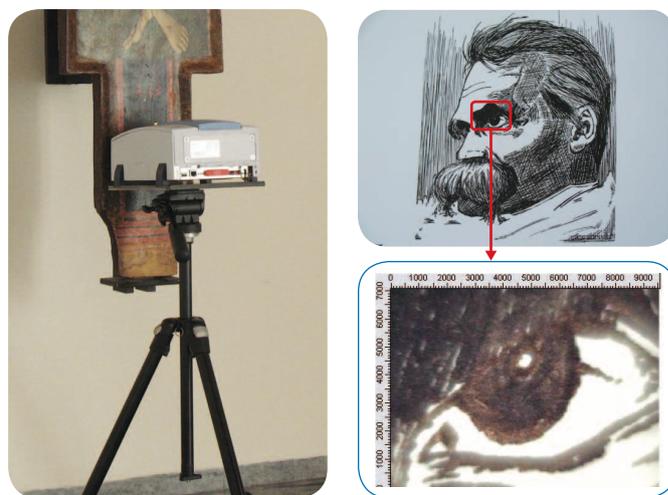
Figure 8: The ALPHA FT-IR spectrometer with the tripod option at "Pinacoteca Nazionale di Bologna" during material screening.
