Application Note AN M137

Failure Analysis of Paper: Determination of the Chemical Identity of Impurities and Inclusions

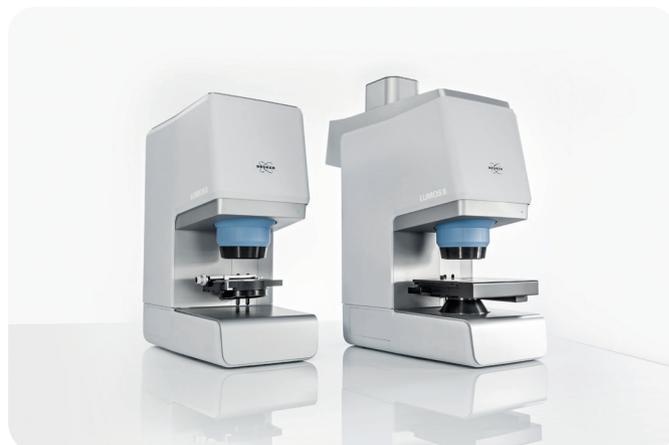
Figure 1: The LUMOS II FTIR microscope allows spatially resolved IR-spectroscopic analysis.

The following examples of typical failure analysis were performed with the Bruker FTIR-microscope LUMOS II (see figure 1). The LUMOS II is a compact, stand-alone instrument with a complete automation of all device components. This results in a very intuitive, purely software-controlled operation of the microscope and allows an efficient use for routine questions. For most analytical questions, the attenuated total reflection (ATR) measurement technique is used. It allows to quickly measuring samples without, or with only minimal sample preparation. For the measurement of the IR-spectra, the LUMOS II microscope automatically contacts the user defined sample positions with the ATR-crystal measurement element. Particles, inclusions, and fibers can be analyzed within seconds and without time consuming sample preparation. Thanks to the complete automation of the ATR-measurement procedure, the LUMOS II is capable to perform grid measurements and thereby creating chemical images.
